Flood Monitoring System Assessment & Improvement Plan Development Report

Submitted by AMR Consults, LLC
to the Upper Brushy Creek Water Control
and Improvement District
February 5, 2013

Flood Monitoring System Assessment and Improvement Plan Development Report

for the Upper Brushy Creek WCID

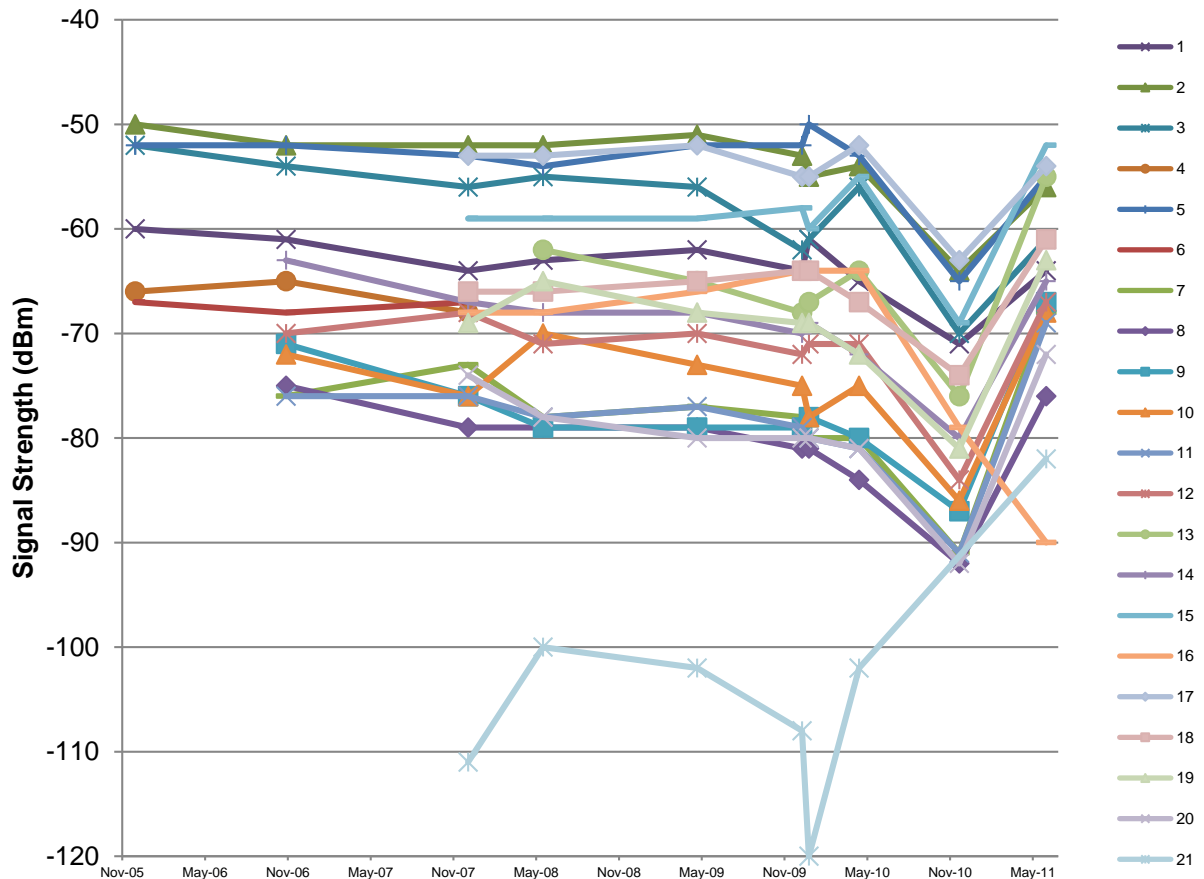
Figure 1 – RSSI Performance History

As evidenced by the dip in RSSI values in Figure 1, something happened in 2010 that caused significant degradation of the system (Tropical Storm Hermine passed through the District during September, 2010; it is possible there could have been residual impacts to communications from the storm). Then in late 2010 or early 2011 a change occurred

that resulted in an improvement that was better than the suffered loss. The only site that appears to have been operating outside a most desirable Radio path is database ID 21 (field site 22). Prior to the improvement(s) in late 2010 or early 2011, this site has operated below -100 dBm. While stations can reliably operate in this range, they do not have the fade margin to survive degradation like what happened in 2010. Yet, the improvements made brought this site back close to the -80 dBm range. Perhaps some modification in system configuration can account for the signal changes during this period.

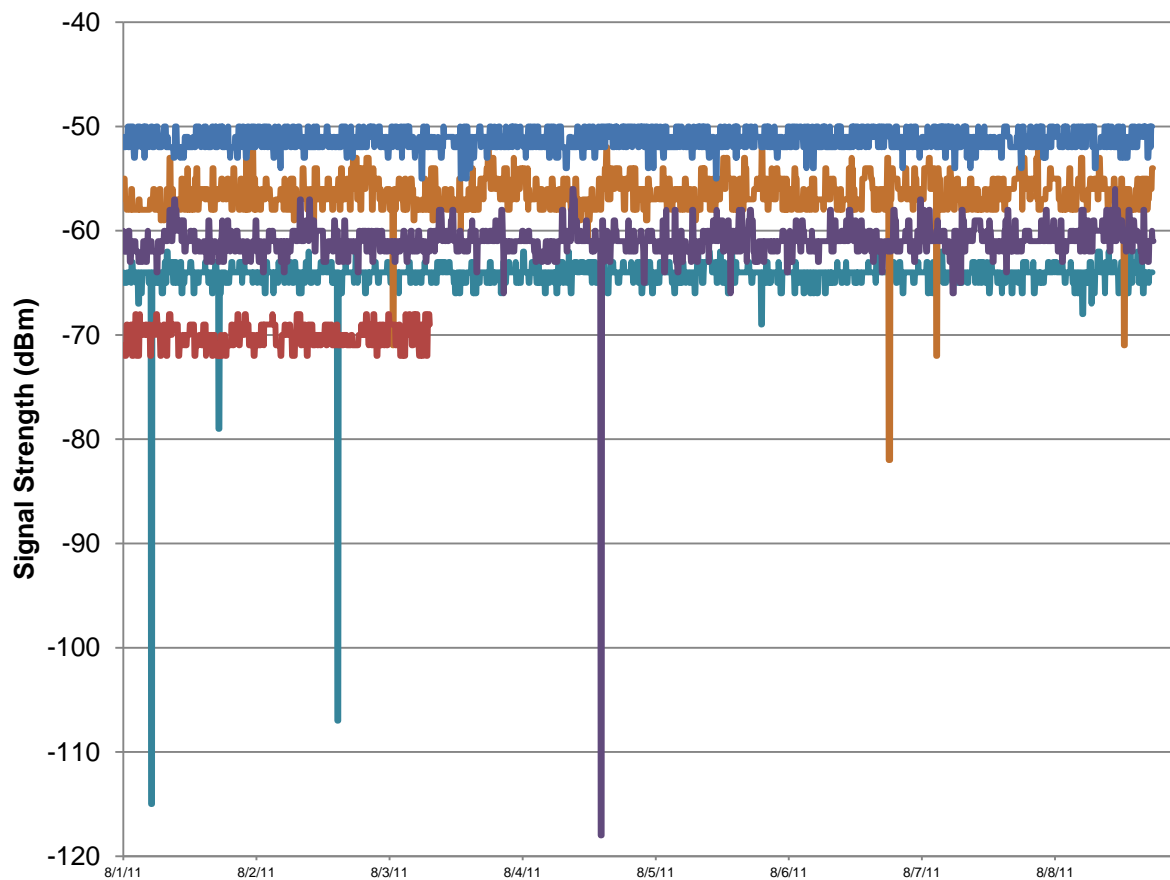
Figure 2 – RSSI 8 Day Interval

Figure 2 contains a graph of 5-minute RSSI values from 19 remote sites (IDs 4 and 6 were reporting values of “0” during period). The main thing to take away from this graph is all the negative spikes that are occurring at several of the sites.

Further review of random samples of data sets indicate that more than one remote site may be trying to communicate with the base station at the same time. This is causing data collisions and will result in increased channel loading due to the augmented retry efforts. The plot in Figure 2 only includes data from 5 sites, so there are likely many other negative values than are shown.
